Briefing on Bay Bridge Bolts – July 10, 2013

THE SAN FRANCISCO-OAKLAND
BAY BRIDGE
SEISMIC SAFETY PROJECT

2008 Rods Failed Due to Hydrogen Embrittlement

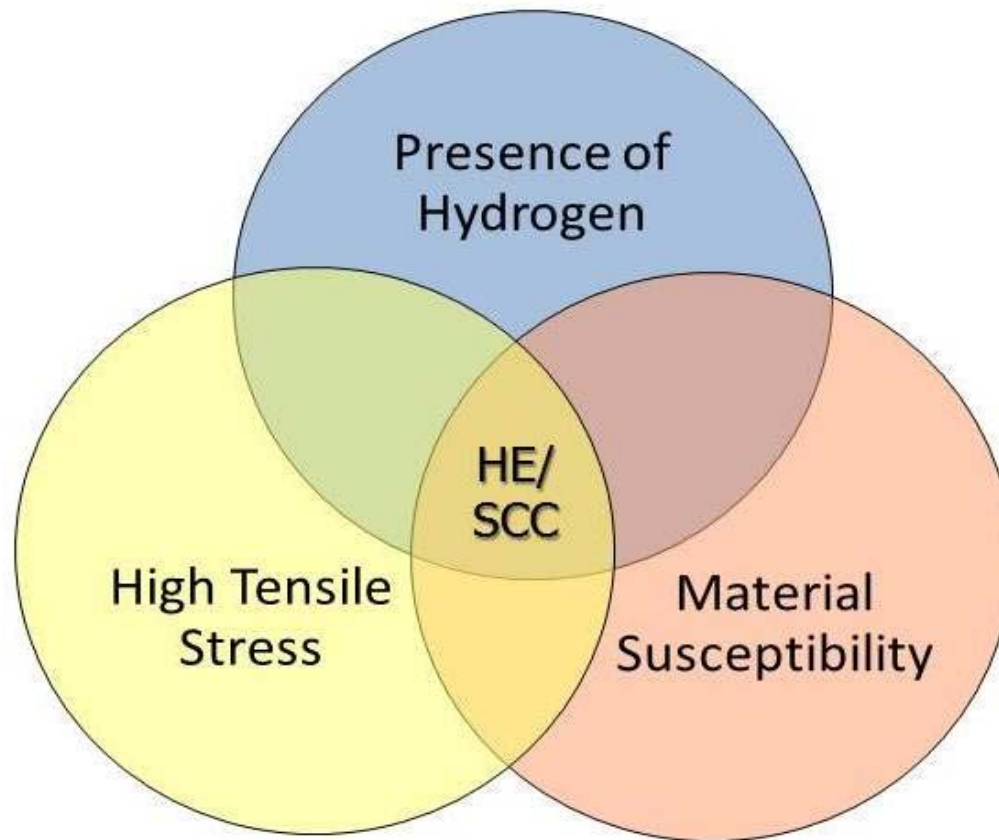
Causes of Hydrogen Embrittlement (HE) or Stress Corrosion Cracking (SCC)

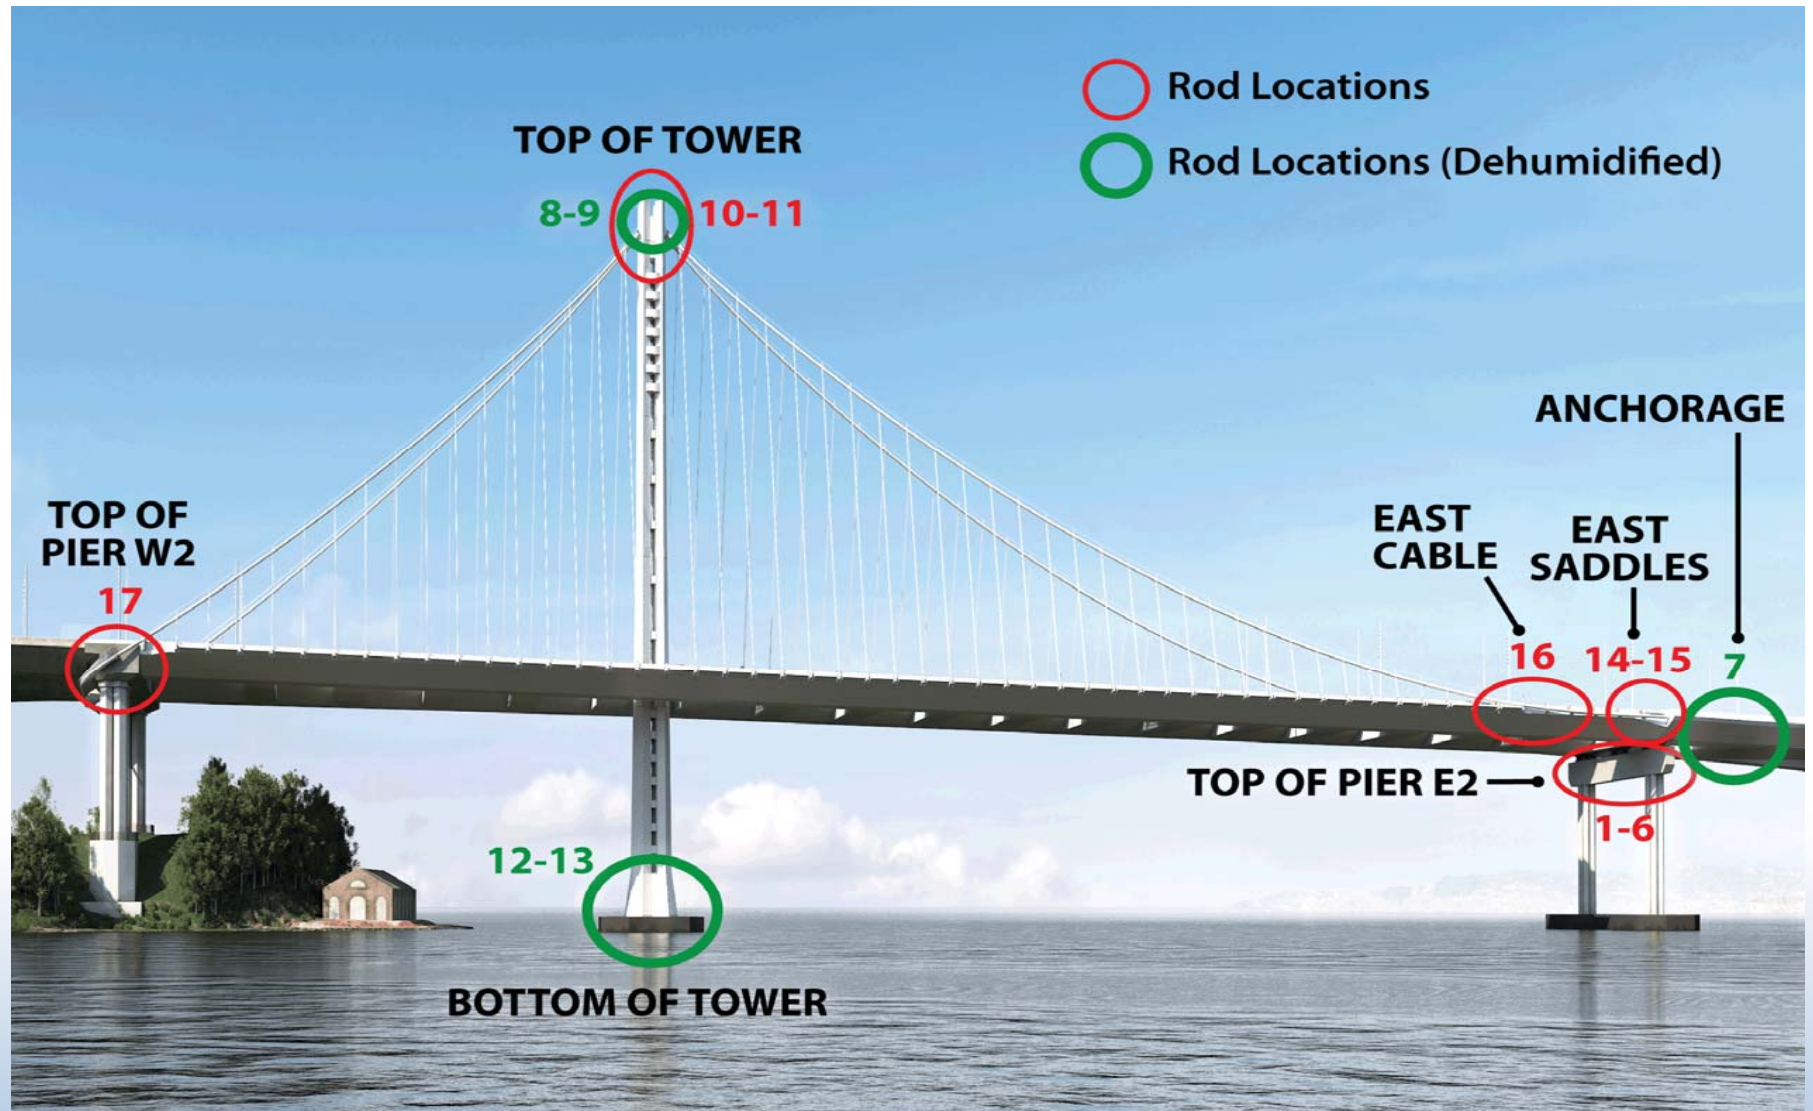
A354 Grade BD Rod Locations on the SAS Bridge

Item No.	Location	Component	Quantity Installed	Diameter (in)	Length (ft)	Tension (fraction of Fu*)
1	Top of Pier E2	Shear Key Anchor Rods (2008)	96	3	10-17	0.7
2		Bearing & Shear Key Anchor Rods	192	3	22-23	0.7
3		Shear Key Rods (top)	320	3	2-4.5	0.7
4		Bearing Rods (top)	224	2	4	0.7
5		Bearing Assembly	96	1	2.5	0.6
6		Bearing Retainer Ring Plate Assembly	336	1	0.2	0.4
7	Anchorage	Parallel Wire Strands (PWS) Anchor Rods	274	3.5	28-32	0.3
8	Top of Tower	Saddle Tie Rods	25	4	6-18	0.7
9		Saddle Turned Rods	108	3	1.5-2	0.5
10		Saddle Grillage	90	3	1	0.1
11		Outrigger Boom	4	3	2	0.1
12	Bottom of Tower	Tower Anchor Rods (Type 1)	388	3	26	0.5
13		Tower Anchor Rods (Type 2)	36	4	26	0.4
14	East Saddles	East Saddle Anchor Rods	32	2	3	0.1
15		East Saddle Tie Rods	18	3	5	0.1
16	East Cable	Cable Band Anchor Rod	24	3	10-11	0.2
17	Top of Pier W2	Bikepath Anchor Rods	43	1.2	1.5	TBD
		TOTAL QUANTITY	2,306

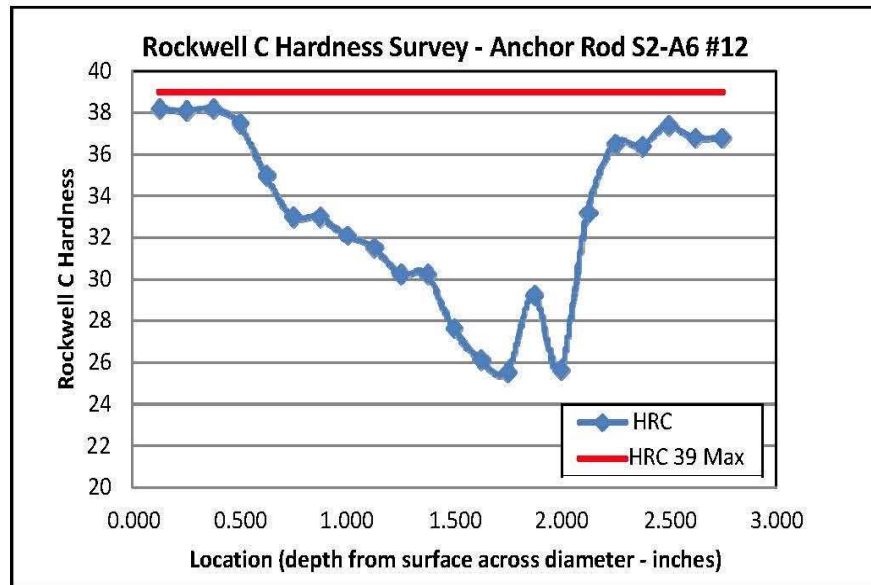
Failed 2008 Rod

Improved Hardness

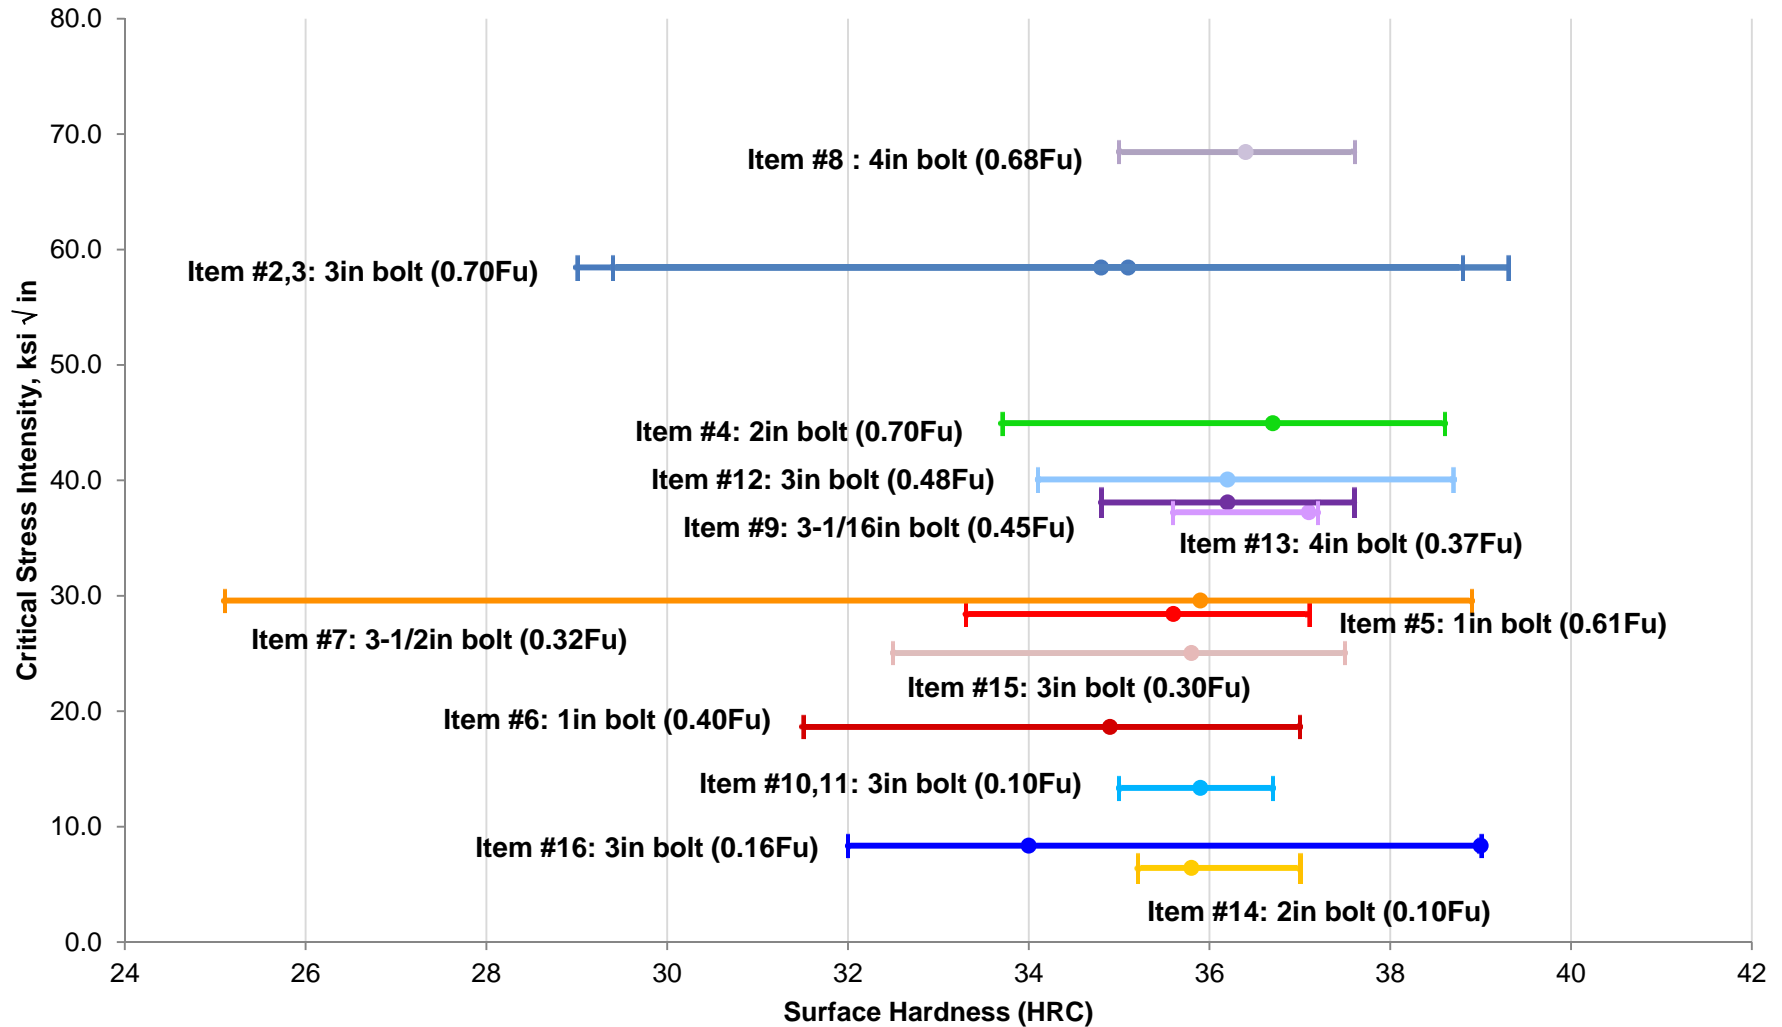
Critical Stress Intensity vs. Surface Hardness Townsend Formulation

(Based on Rod by Rod Data from Test 1: June 21, 2013)
